RADIO FREQUENCY IDENTIFICATION IN HORSES: AN INDEPENDENT ANALYSIS

Unione Nazionale Incremento Razze Equine (U.N.I.R.E.), piazza San Lorenzo in Lucina n°4, 00186 – Roma, Italy

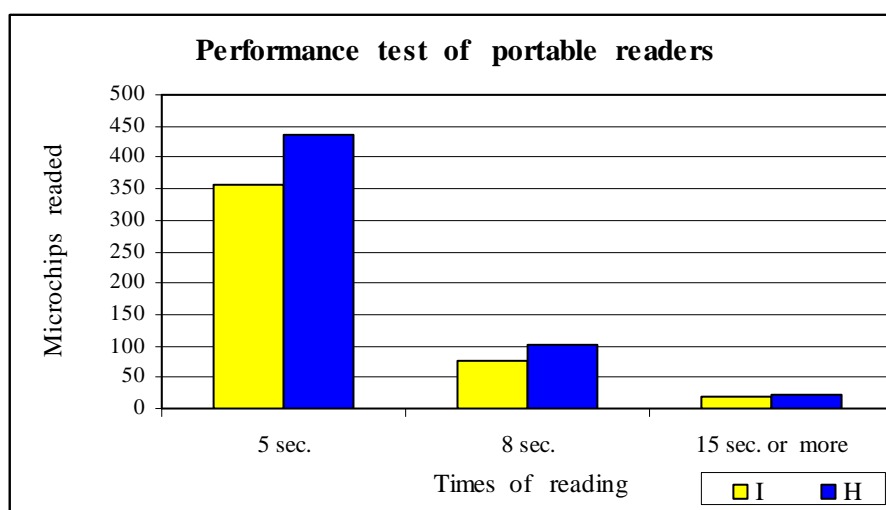
As for the 10 digit microchips (560 horses), (I) reader could not read 160 of them (20 %) and (H) reader was quicker (see graph). Follow the microchips detected in each neck's placement:

Only the (I) reader recorded 15 digit microchips (19.4 %), of which 94 % was detected within 5 seconds, 4 % in 5 to 15 seconds and the last 2 % within a time over 15 seconds (one microchip was on the right side).

Most of the transponders were detected in standard position (90% on the neck's dorsal line, 10% in other sites). Reader (I) could not detect about 20 % of 10 digit transponder, despite according the advertisement it records all microchips implanted in the last 10 years. However, its lost of skill could be correlated to the gradual lost of energy. This method of identification is convenient and quick, even if it is advisable that companies improve the reading skill of the instruments and racing authorities carry on with continuing education for veterinarians charged of the implants, to avoid non-standard implantation sites. Further studies are needed to explain rare cases of failed reading, which force the authorities to still use the outline diagram, not because of their statistic significance but for the advisability correlated to the single horse importance.
